SUBJECT: Review of STS-86 USA SAFER failure

STS-86 USA SIMPLIFIED AID FOR EVA RESCUE (SAFER) FAILURE

MISHAP DATE: October 1, 1997

FAILURE REVIEW BOARD REPORT

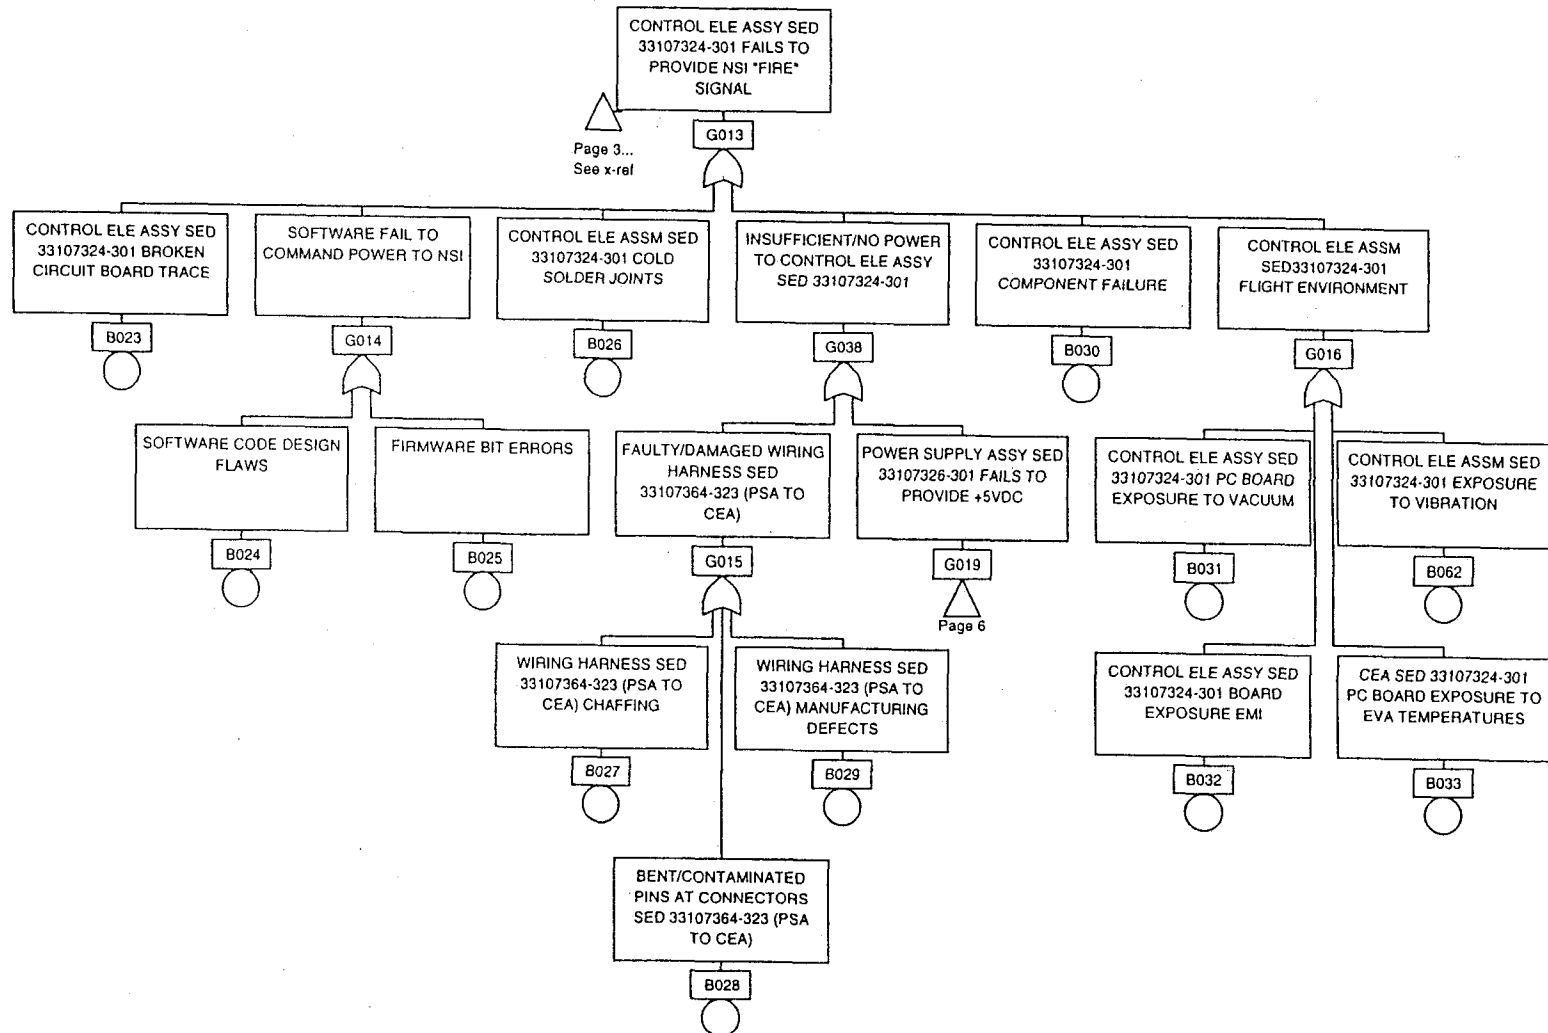
A review of the Fault Tree (Figure 8) at this time showed that every path (ironically) had been traced successfully. Focusing on page 4 of 10 of Figure 8, the chamber testing had shown that insufficient power (current) was being sent by the Valve Drive Assembly (VDA) to the wiring harness (W/H) going to the NSI. This condition is represented at the top of page 4 of Figure 8 by Block G009. Some fault phenomenon unknown to the FRB was occurring when the system parts were integrated. The separate pieces of the design were performing as designed when tested separately.

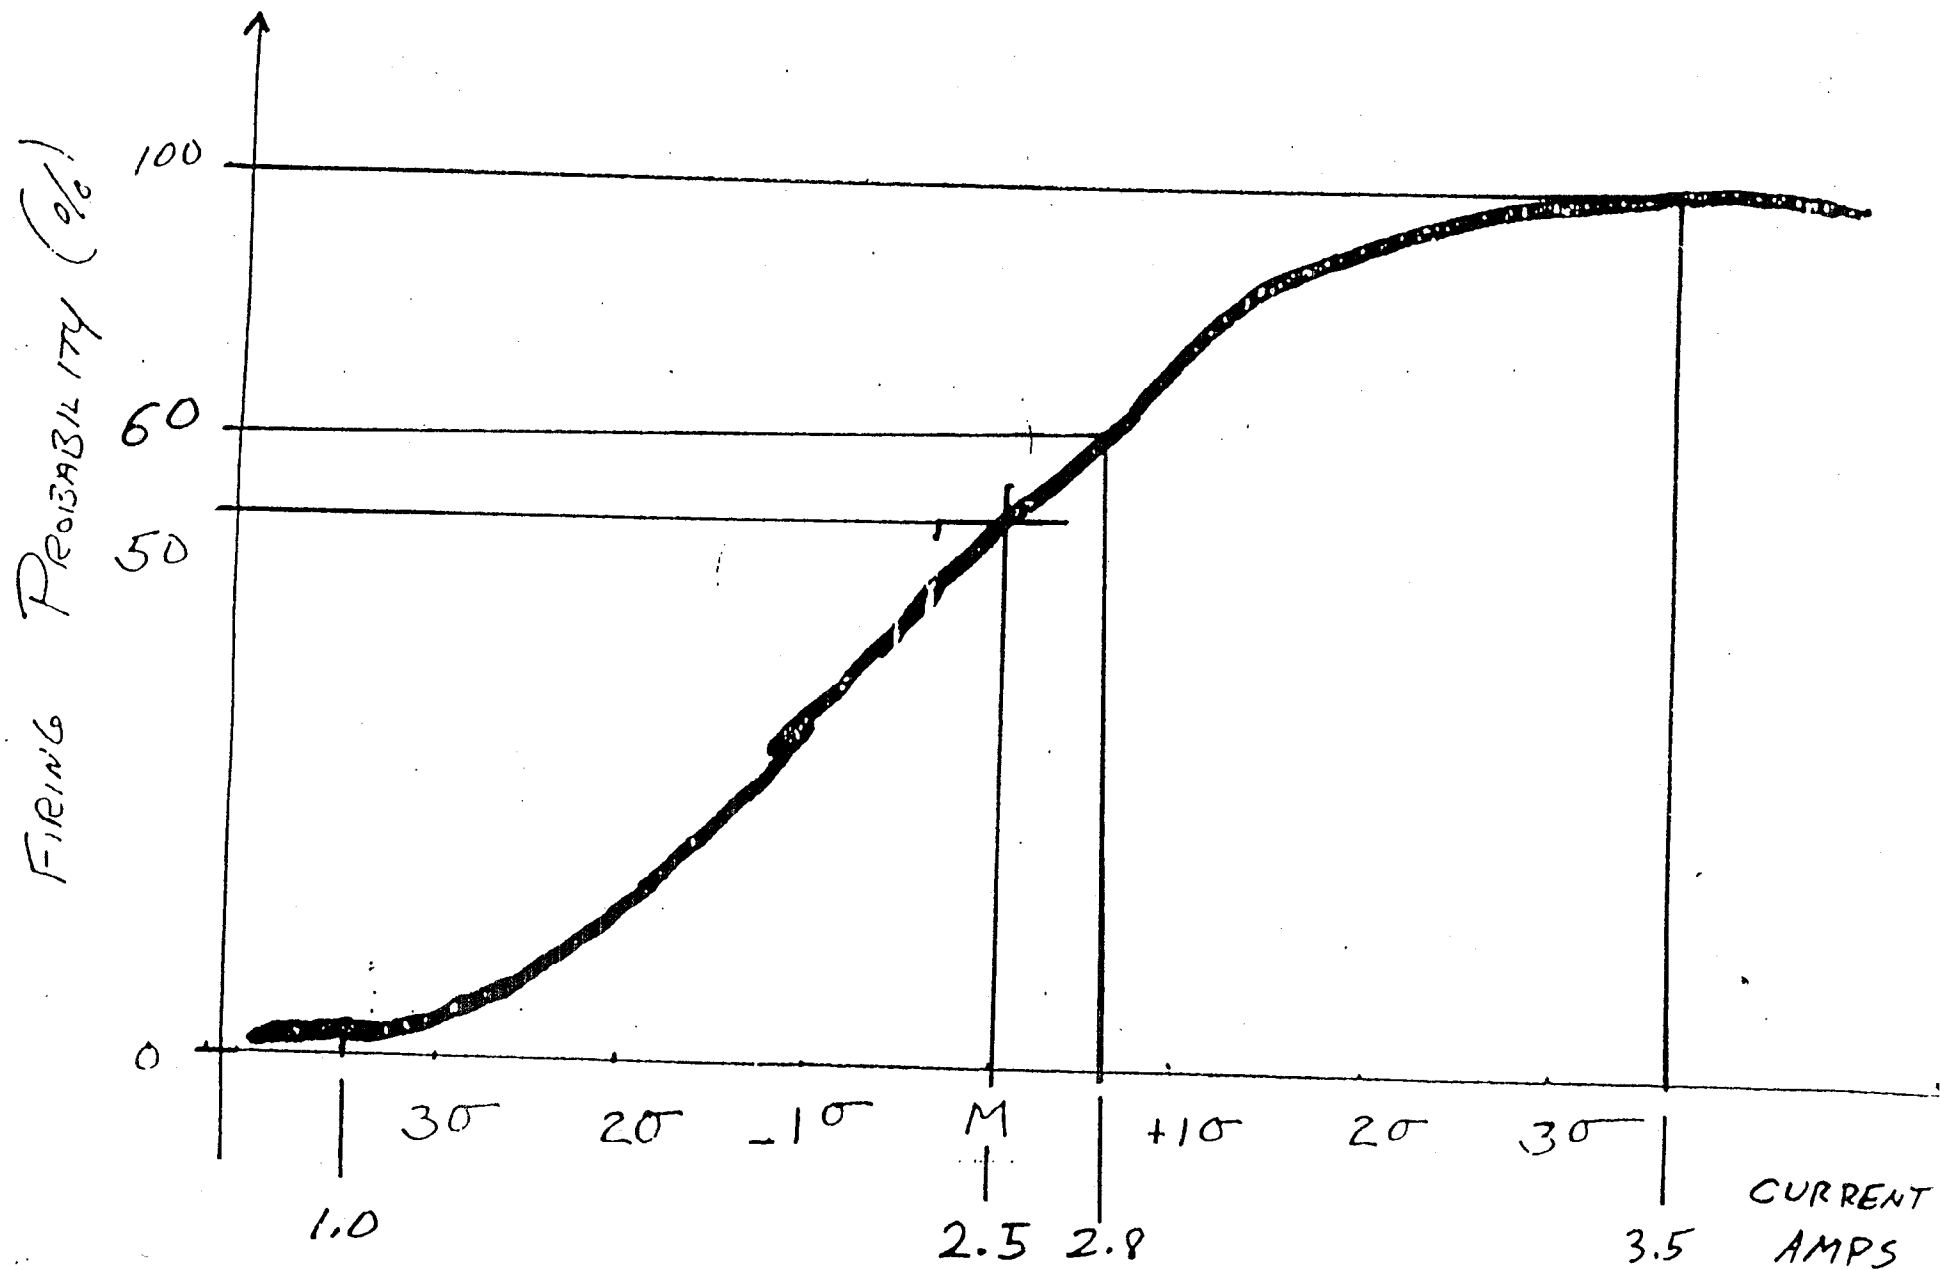
Figure 10: NSI current versus Probability of firing

The NSI did not fire because there was a change in the NSI resistance as the NSI "fire" current pulse was applied to the NSI by the avionics circuit. This caused the NSI "fire" current level (designed at 4.1 amps) to drop (to 2.8 amps) below the "all fire" (3.5 amps) NSI current specification. The NSI resistance was measured at 1.09 ohms before installation into the SAFER. During application of the "fire" pulse, the resistance changed due to "ohmic heating" to approximately 1.6 ohms. The change in resistance caused the 4.1 amp NSI "fire" pulse to drop to 2.8 amps because of the avionics circuit constant voltage design. At 2.8 amps, the probability of firing the NSI is approximately 60%.

To prove the theory that the successful and unsuccessful firings were based solely on probabilities (recall Figure 10), a simple statistical analysis was performed. The analysis showed that if 14 different NSI firings were attempted and none fired then the circuit would NEVER fire an NSI with 99.99% certainty. A test plan was drawn up to obtain 14 NSI's similar to the flight failure NSI. Each NSI firing would only be attempted once (repeated firings can "glaze" the bridge wire thus affecting its probability of firing) and the firing was in the instrumented "bombs" used previously. The flight unit and flight battery would be used. If and when an NSI fired, the test would be halted.

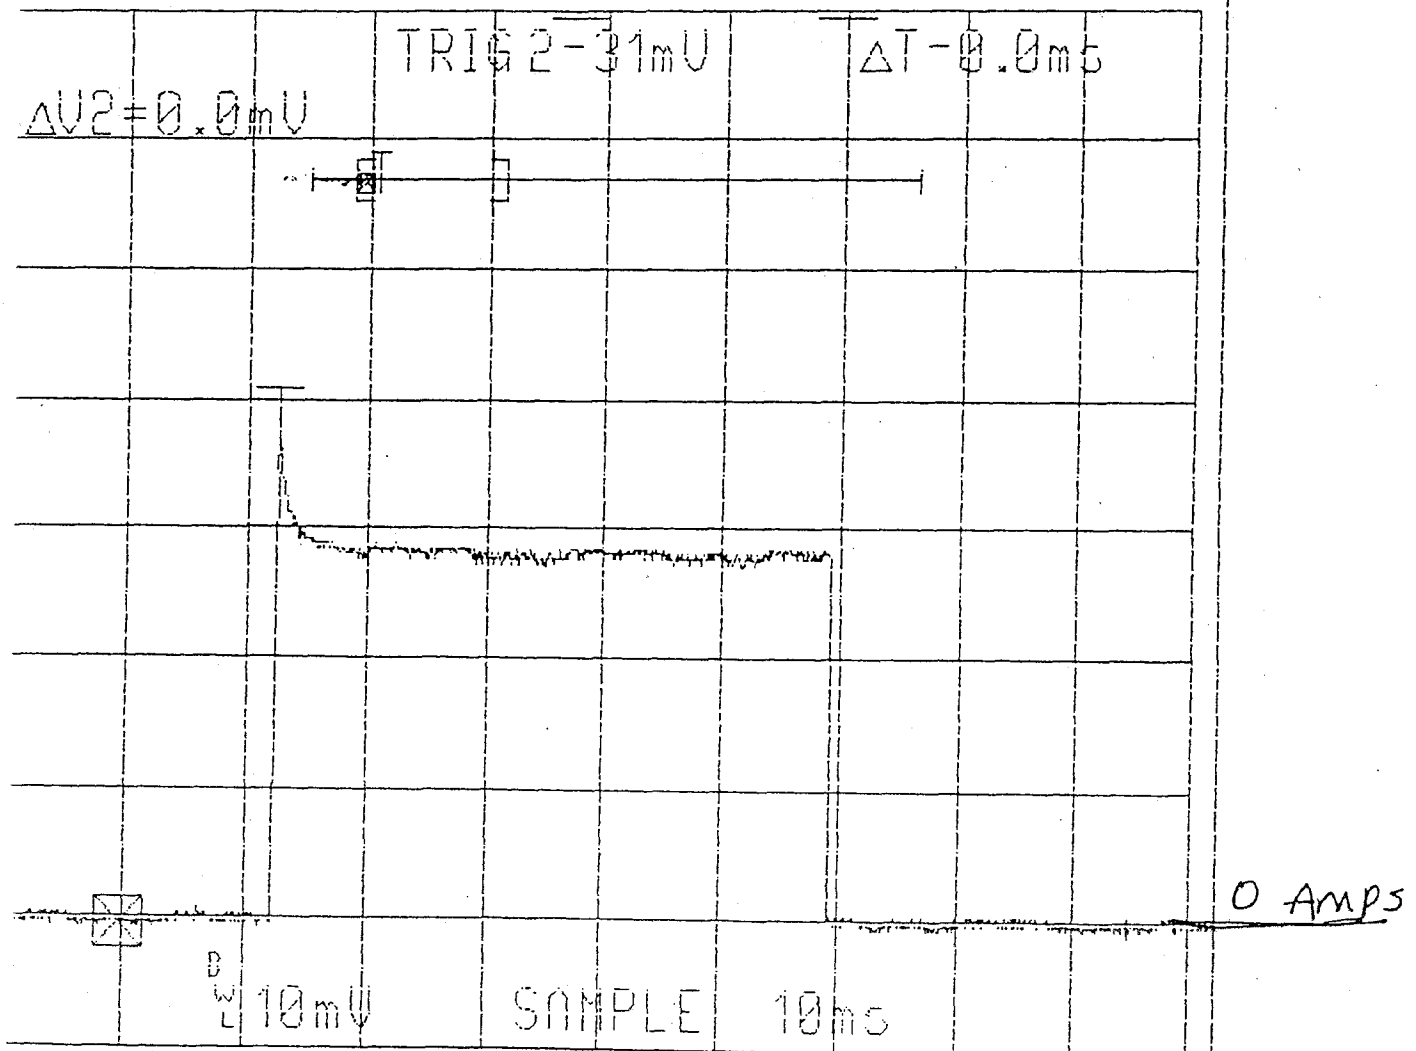
Figure 13: Off nominal NSI fire current pulse

A summary of the data at this point showed: (1) that the resistance of the NSI firing circuit was increasing (Figure 13), (2) that the success of the two NSI firings on the certification unit could have been probability/luck (Figure 10) shows a 60% probability of a firing at 2.8 amps), and (3) that the failure of the flight unit and the Chamber H firing attempts was also probability/luck.

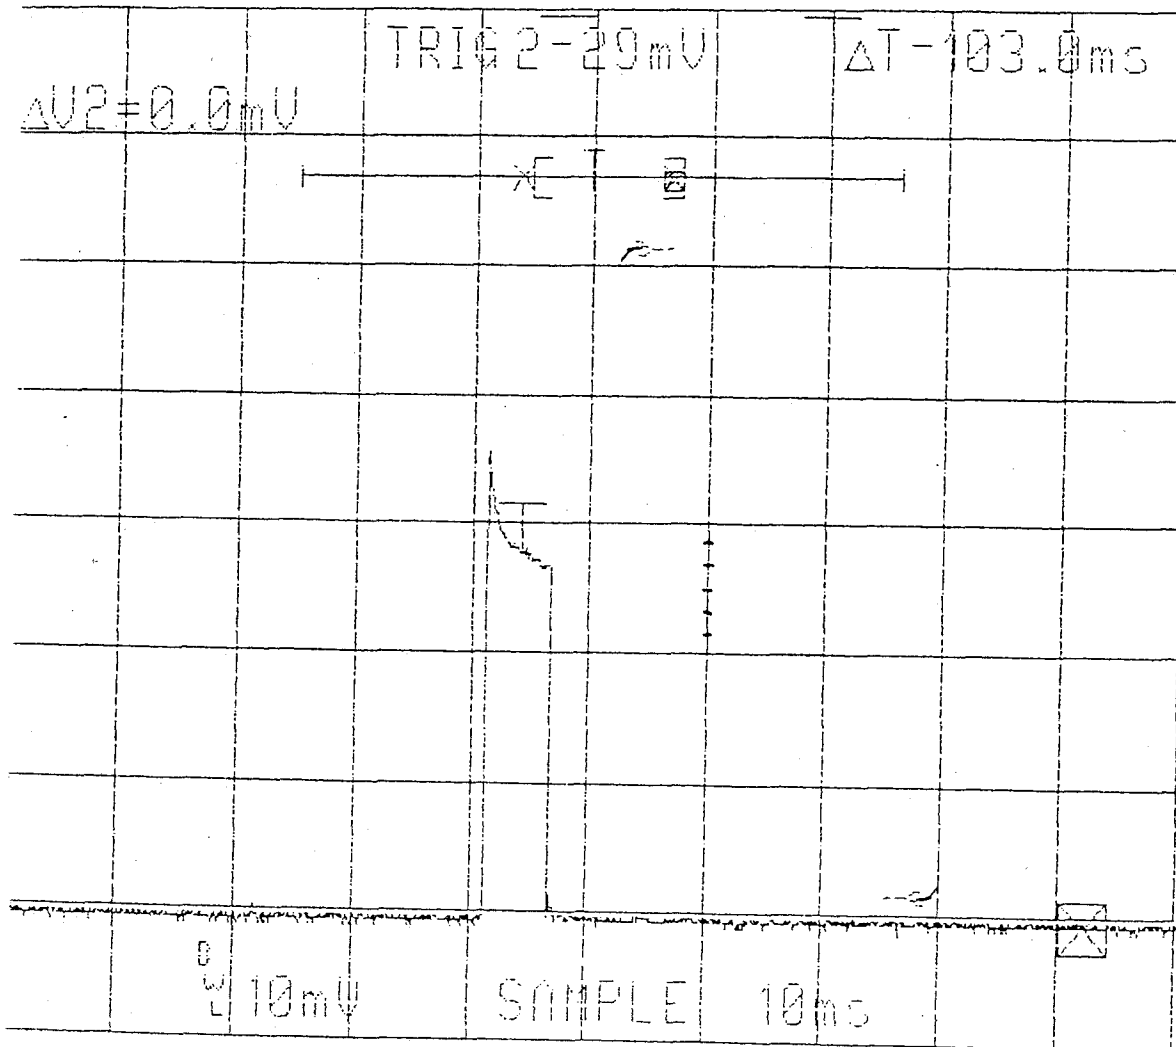
The current trace (Figure 14) showed the same behavior as seen in the previous tests: the current was 3.5 amps (on its way to 4 amps when the resistance change occurred), then dropped to 2.7 amps (indicating the resistance change). The current then dropped to zero when the NSI fired. The FRB concluded that the flight SAFER failure was due to the change in resistance of the NSI and the constant voltage circuit's inability to supply 3.5 amps or more to the NSI. The resistance change drove the circuit's current down to 2.8 amps (60% probability of successful firing point), below the 3.5 amp "all fire" value. The successful firing of two NSI's in the certification unit and the failure of the NSI to fire in Unit #1005 during STS-86 were due to probabilities.

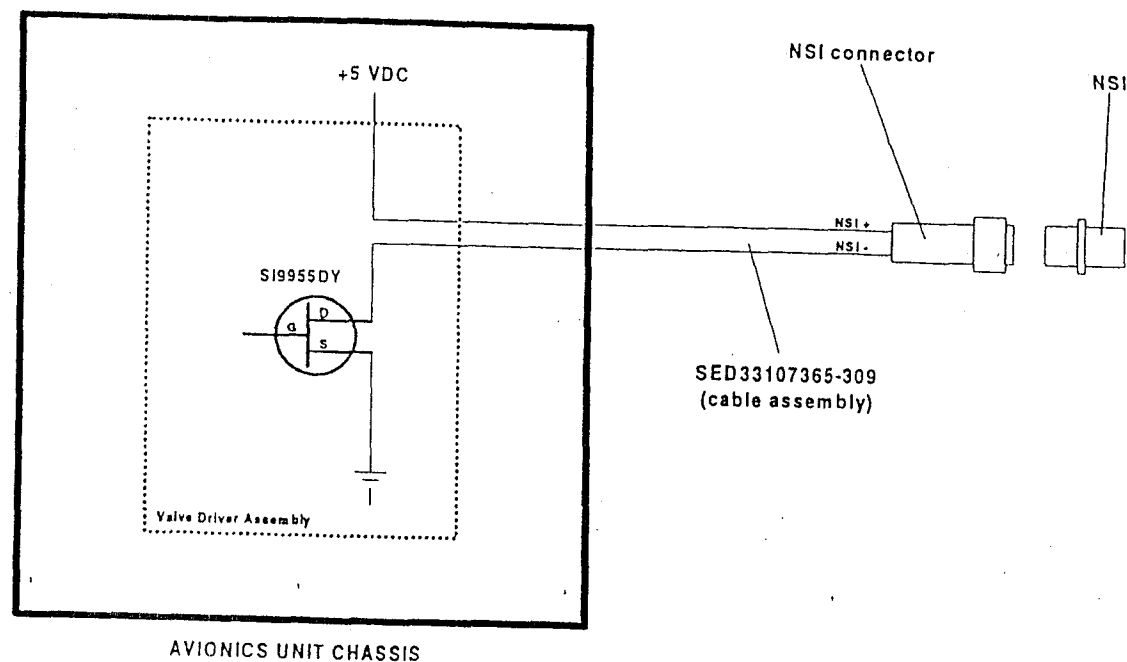
Figure 15: STS-86 NSI circuit design (page 1 of 2)

The SAFER avionics circuit could not supply more than 2.8 amps as the NSI resistance increased because of its "constant voltage" design ($V=IR$, Voltage = Current x Resistance). Aboard the shuttle, there is only one other known NSI system with this circuit approach (the non-critical aft hazardous gas sampling system). A typical NSI circuit uses a capacitive discharge approach to fire the NSI. In capacitive circuits, large, excessive amounts of power are delivered to the NSI.

Technical Finding #2: The NSI's resistance changed from 1.09 ohms to approximately 1.6 ohms when the "fire" current pulse from the SAFER avionics was applied to the NSI. The increased resistance caused the current to drop from 4.1 amps to 2.8 amps, well below the all fire 3.5 amp current.

- SAFER NSI DRIVE CIRCUIT CDR BASELINE WAS MODIFIED TO PROVIDE NSI CURRENT FROM A 5 VDC 30 WATT SWITCHING REGULATOR USED IN THE AVIONICS DESIGN.. THE CIRCUIT PROVIDES 4.1 AMPS NOMINAL CURRENT FOR A NSI RESISTANCE OF 1.05 ohms +/- .10 ohms.**
- FOR 4.1 AMP NSI CURRENT, THE BATTERY ASSEMBLY MUST PROVIDE ~26 WATTS TO THE AVIONICS SUBSYSTEM TO FIRE NSI IN ADDITION TO THE BASELINE AVIONICS SUBSYSTEM CURRENT.
- DURING CERTIFICATION UNIT TESTING, ALL NSI FIRING ATTEMPTS WERE SUCCESSFUL.
- POST STS-86 FLIGHT ANOMALY TESTING HAS DETERMINED THAT THE NSI RESISTANCE INCREASES TO ~1.63 ohms DUE TO BRIDGEWIRE HEATING. FOR A NSI RESISTANCE OF 1.63 ohms, THE NSI CURRENT PROVIDED IS ~2.7 AMPS.**

** NSI BRIDGEWIRE SPECIFICATION IS 1.05 ohms +/- .10 ohms. THE ALL-FIRE CURRENT IS 3.5 AMPS.

Recommendation #1: *Redesign the SAFER avionics circuit which generates the NSI firing pulse. The redesign effort should consider swapping the circuit from a constant voltage circuit to a capacitive discharge circuit.*
