# Learning from Other People's Mistakes

*Most satellite mishaps stem from engineering mistakes. To prevent the same errors from being repeated, Aerospace has compiled lessons that the space community should heed.*

**Paul Cheng and Patrick Smith**

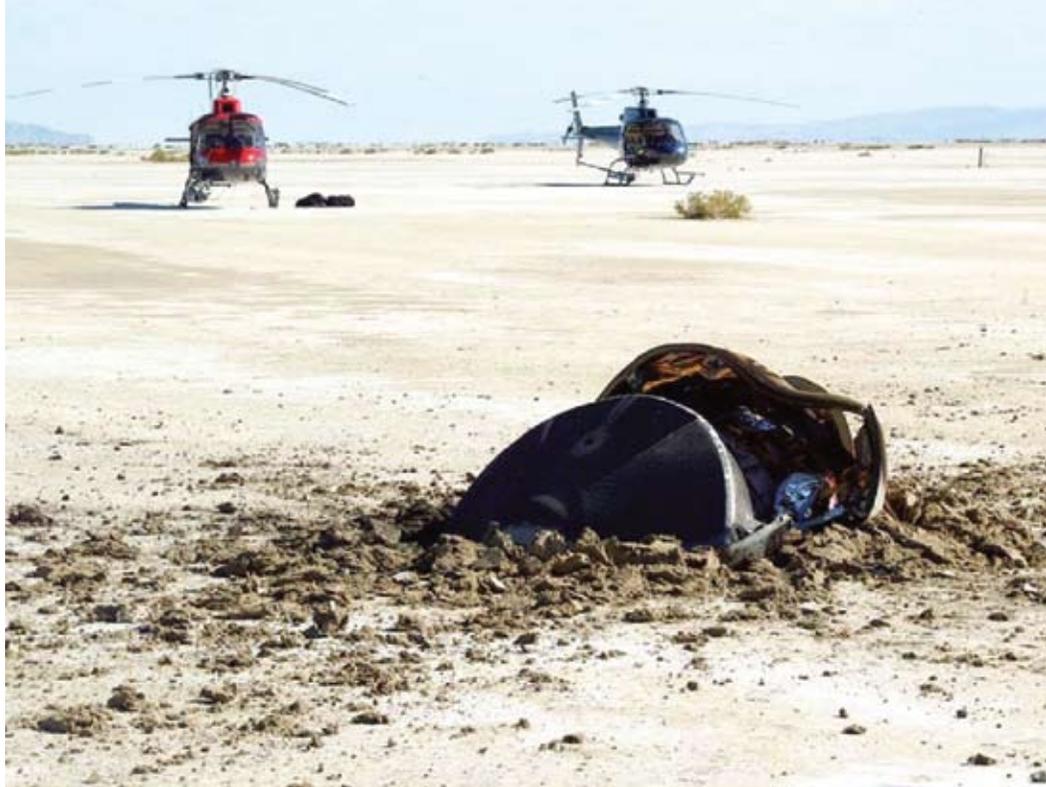
The Genesis capsule, embedded in the sands of Utah after its parachute system failed to deploy in September 2004. The Mishap Investigation Board said the likely cause was a design error involving the orientation of gravity-switch devices.

More recently, the Genesis spacecraft crashed. Genesis brought back solar-wind samples. During reentry, aerodynamic deceleration was supposed to cause a parachute to unfold. Genesis’s avionics design was derived from an earlier mission, Stardust, but was too complex to fit into Stardust’s one-box package. Genesis designers cut and pasted Stardust’s schematic into a new two-box design. The Stardust unit had been spin tested, but the two boxes in Genesis were difficult to spin together. So, believing that the design was flight proven, Genesis engineers simply verified the new assembly “by inspection.” Unfortunately, nobody knew that a pair of deceleration sensors were direction-sensitive—even the Stardust drawings did not flag any polarity constraint. The sensors were by chance turned sideways in the new layout, and as a result, the parachute could not open.

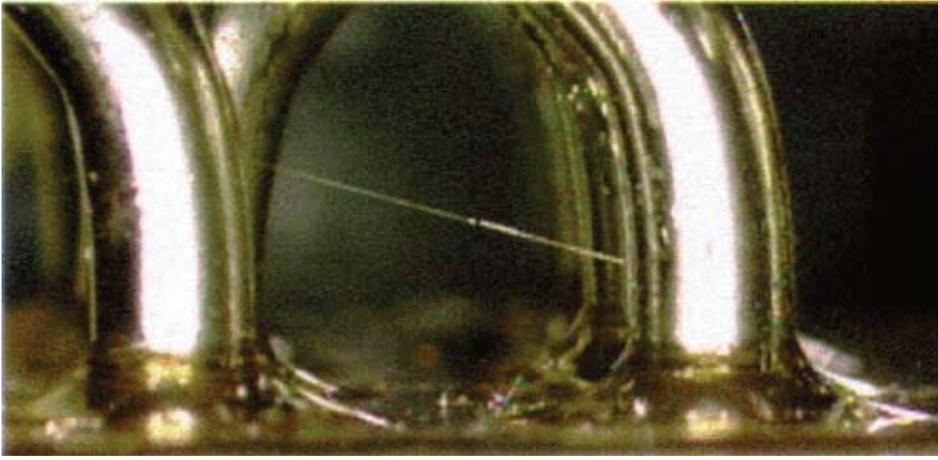
Pure tin plating can grow conductive whiskers. Numerous satellites have been disabled because whiskers inside the control processors caused plasma arcing that blew the fuses.

failures. Fuses, circuit breakers, and other devices are intended to protect upstream components, but careful design is required to prevent the safety devices from misbehaving. Plasma arcing most frequently results from pure tin plating that grows conductive filaments (commonly known as “whiskers”). Numerous satellites, such as Galaxy VII, had been disabled because whiskers grew on the relays of their control processors, causing arcing that blew the fuses.
