GSFC NASA ADVISORY

1. Advisory Number NA-GSFC-2004-05		2. Subject Cable Failure Attributable to Workmanship Error During Assembly of COTS Connector.		
3. Manufacturer Trompeter Electronics, Inc. 5550 E. McDowell Road Mesa, Arizona 85215		4. Manufacturer CAGE Code 60637		5. Federal Stock Code N/A

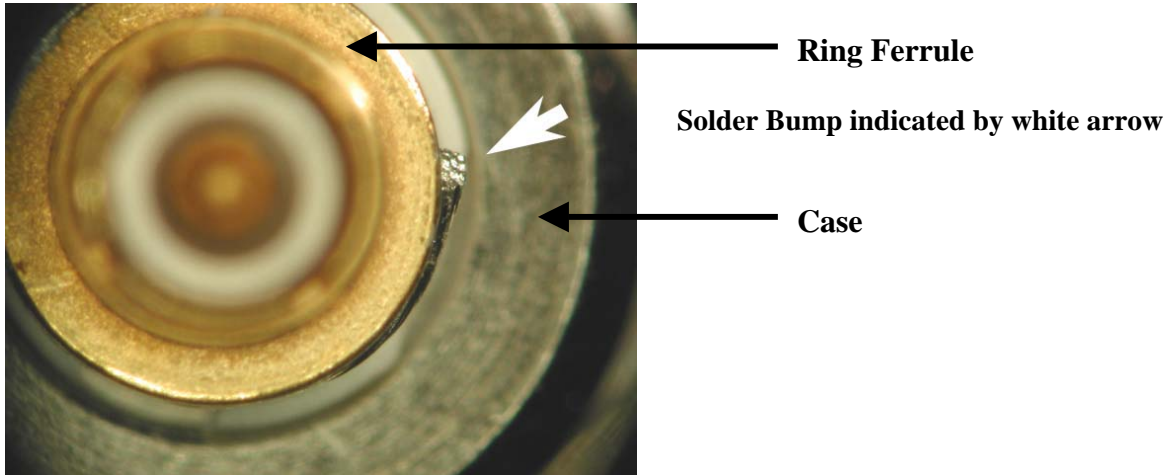
11. Problem Description and Details: A GSFC project had cable assembly failures due to shorted connectors. Trompeter Electronics, Inc. manufactured these COTS connectors per catalog p/n PL3155-47. A GSFC failure analysis determined that the connector failures were caused by a solder bump on the ring ferrule, which wore through the insulation sheath and shorted to the connector case. This solder bump protrusion is illustrated in Figures 1 and 2 on page 2. The root cause failure mechanism was attributable to poor GSFC workmanship during the connector assembly operation. Step 4B of the Trompeter Assembly Instruction TAI-125 requires the following: "Solder white conductor to inner shield, between ridges, being careful not to allow solder to extend above ridges". As illustrated in Figure 3, the solder extended beyond the ridge line, thereby causing a solder protrusion into the insulation and a resultant shorting condition to case.

Figure 1: Solder Bump on the ring ferrule shorting through the insulation to the case.

12. Action Recommended: 1) When appropriate, it is recommended that the projects use crimped connectors, rather than relying on a cable design that uses soldered connectors. 2) If this style of Trompeter connector is assembled to cables, ensure that the manufacturer instructions are followed, especially assuring that neither solder nor conductor extends beyond the ridge of the ring ferrule.

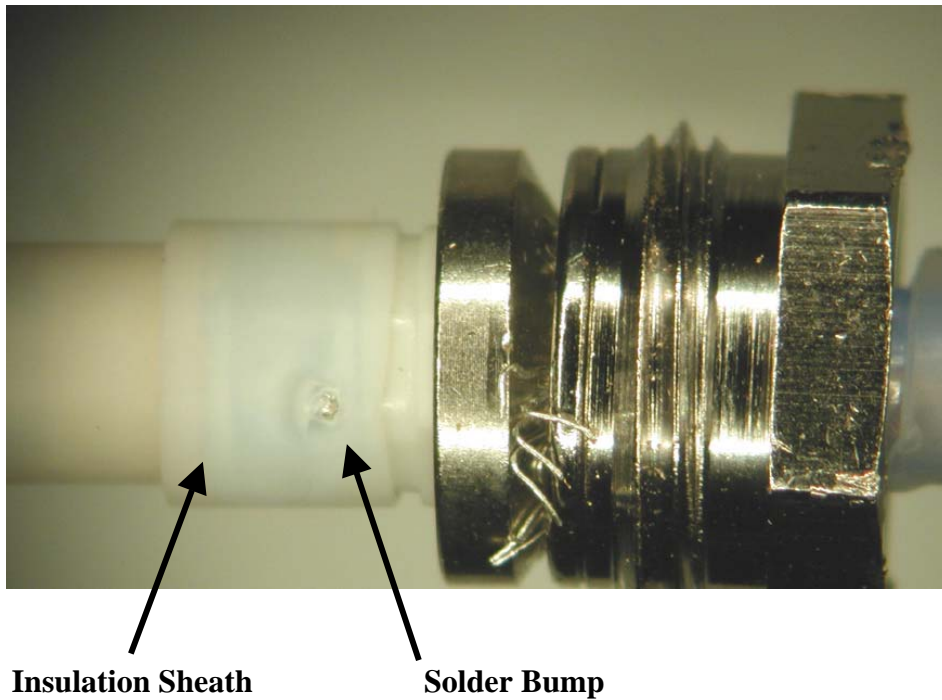
Figure 2: After connector disassembly, the same solder bump protruding through the insulation sheath.

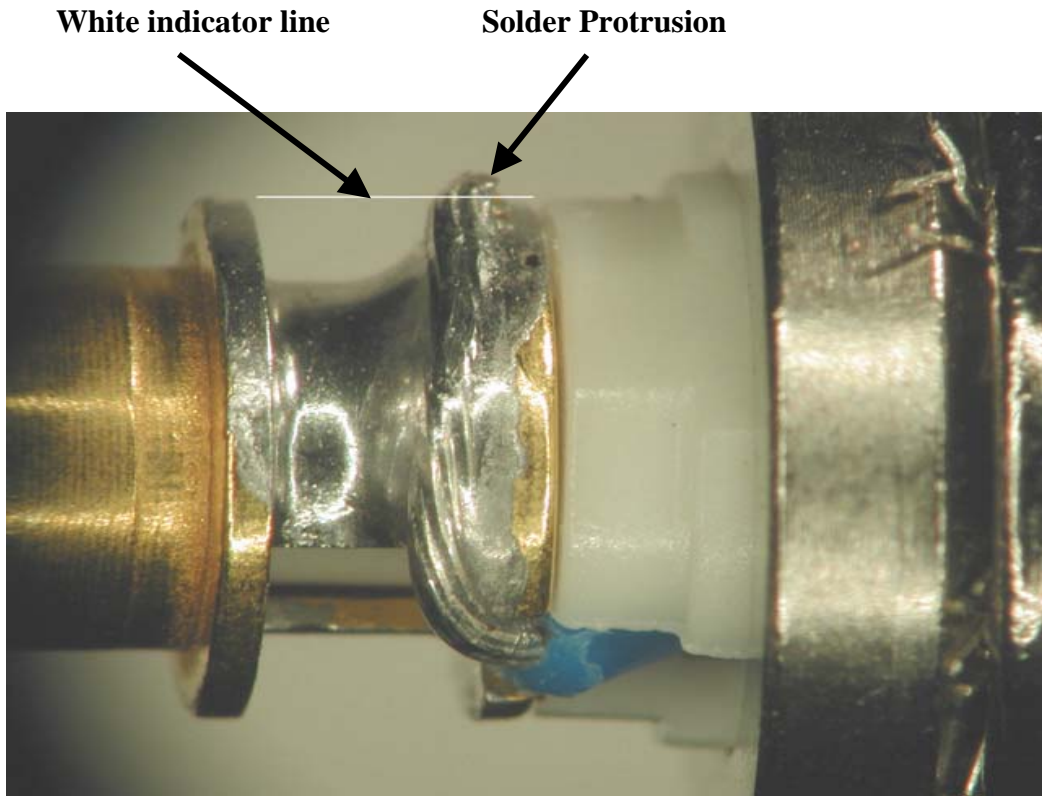
Figure 3: Workmanship error regarding step 4B of the Trompeter Assembly Instruction TAI-125, which requires “Solder white conductor to inner shield, between ridges, being careful not to allow solder to extend above ridges”. In this shorted connector failure, the solder bump protrudes above the ridge line, which is indicated by the white indicator line.
