SUBJECT: Review of STS-86 USA SAFER failure

STS-86 USA SIMPLIFIED AID FOR EVA RESCUE (SAFER) FAILURE

MISHAP DATE: October 1, 1997

FAILURE REVIEW BOARD REPORT

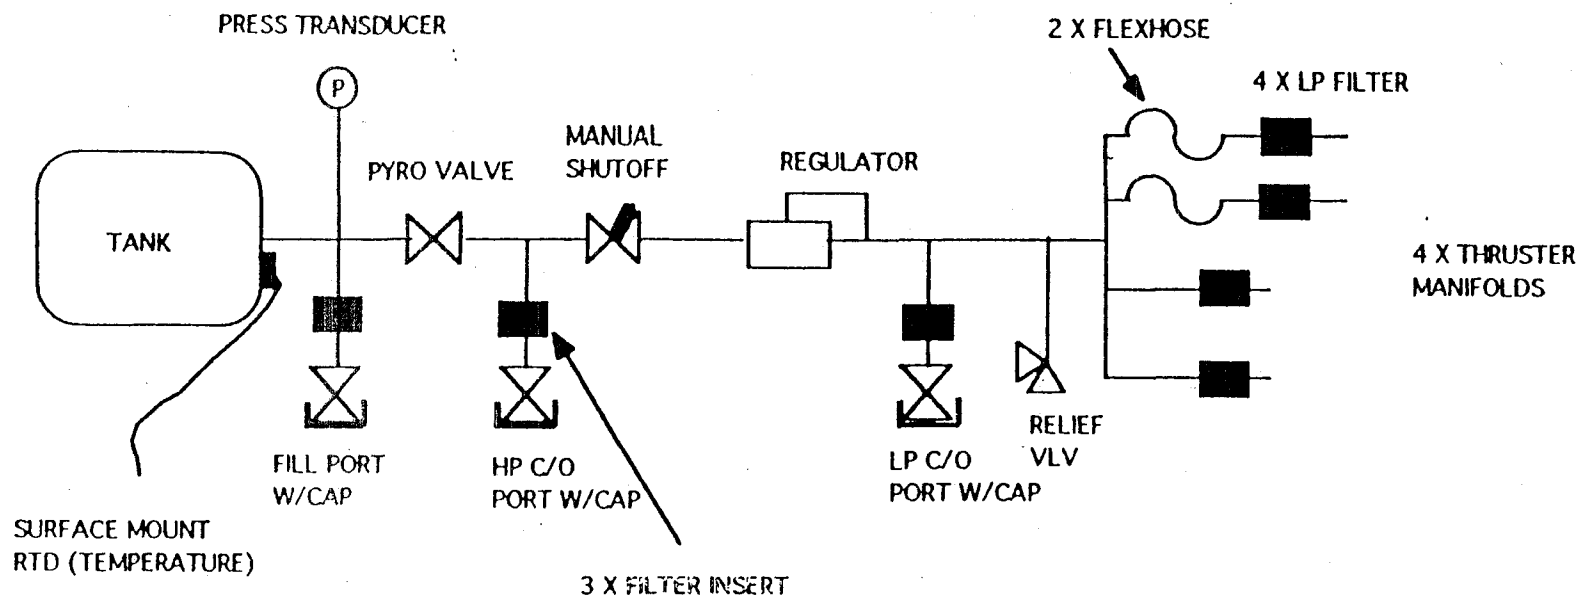
Figure 3: USA SAFER propulsion system

SAFER is powered by an external 36-volt battery pack located on the bottom of the SAFER avionics package. The nitrogen propulsion system (Figure 3) consists of a tank, a pyrotechnic ("pyro") valve, a manual isolation valve, a regulator, a relief valve, and 24 thrusters. The manual isolation valve is opened by the crew member before exiting for an EVA. The pyro valve is opened when the SAFER unit is turned on by taking the hand controller power switch to ON. The switch throw results in the generation of an electrical signal sent by the avionics to a pyrotechnic NASA Standard Initiator (NSI). The NSI is a simple system consisting of a thin wire (the "bridge wire") which passes through the propellant (Figures 5 and 6). Current is applied to the bridge wire which heats up and eventually breaks (potentially explosively under high current). The NSI fires as the bridge wire heats and the resulting expanding gas opens the pyro valve. The NSI is used extensively on each shuttle flight (Figure 7). A pyrotechnic valve was selected because it hermetically seals the nitrogen supply tank to guarantee the units can last for at least 1 year between servicing as required for International Space Station operations. The SAFER thrusters may either be fired automatically by the SAFER avionics in an attempt to establish a stable attitude when in Automatic Attitude Hold, or by the crew member moving the hand grip on the hand controller.

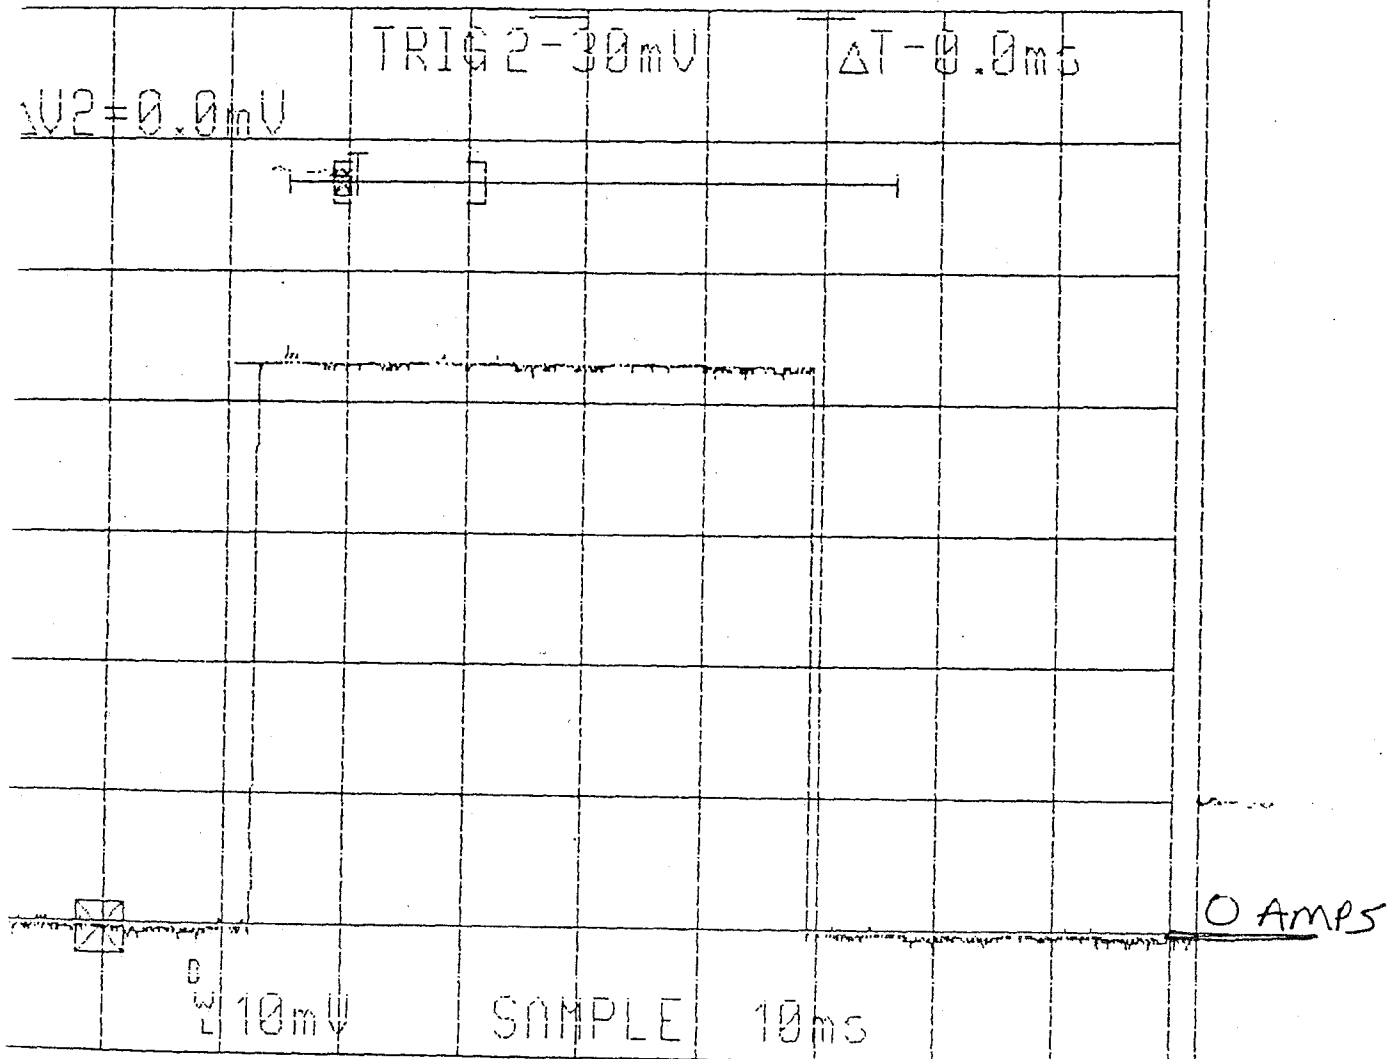
Figure 12: Nominal/design NSI fire current pulse

CURRENT SCALE - 1.0 AMP/DIVISION
TIME SCALE - 10 msec/DIVISION

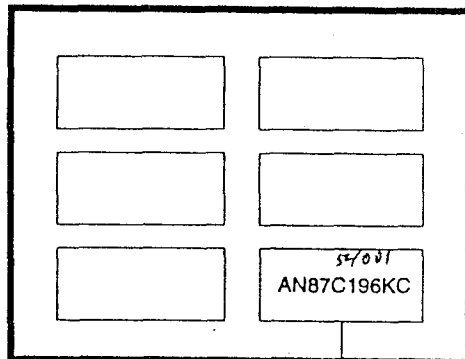
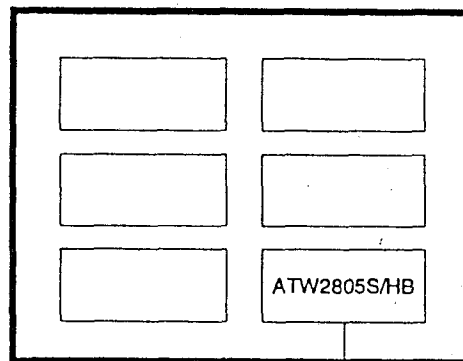
Figure 15: STS-86 NSI circuit design (page 1 of 2)

- The SAFER avionics used a constant voltage source (Figure 15) to generate the NSI firing pulse with little design margin. The great majority of NSI circuits use a capacitive discharge circuit to supply the NSI fire pulse. Capacitive discharge circuits are designed to supply substantial power and margin. (Note: it was later documented, in early December, that these circuits are also insensitive to changes in NSI resistance.)

** NSI BRIDGEWIRE SPECIFICATION IS 1.05 ohms +/- .10 ohms. THE ALL-FIRE CURRENT IS 3.5 AMPS.

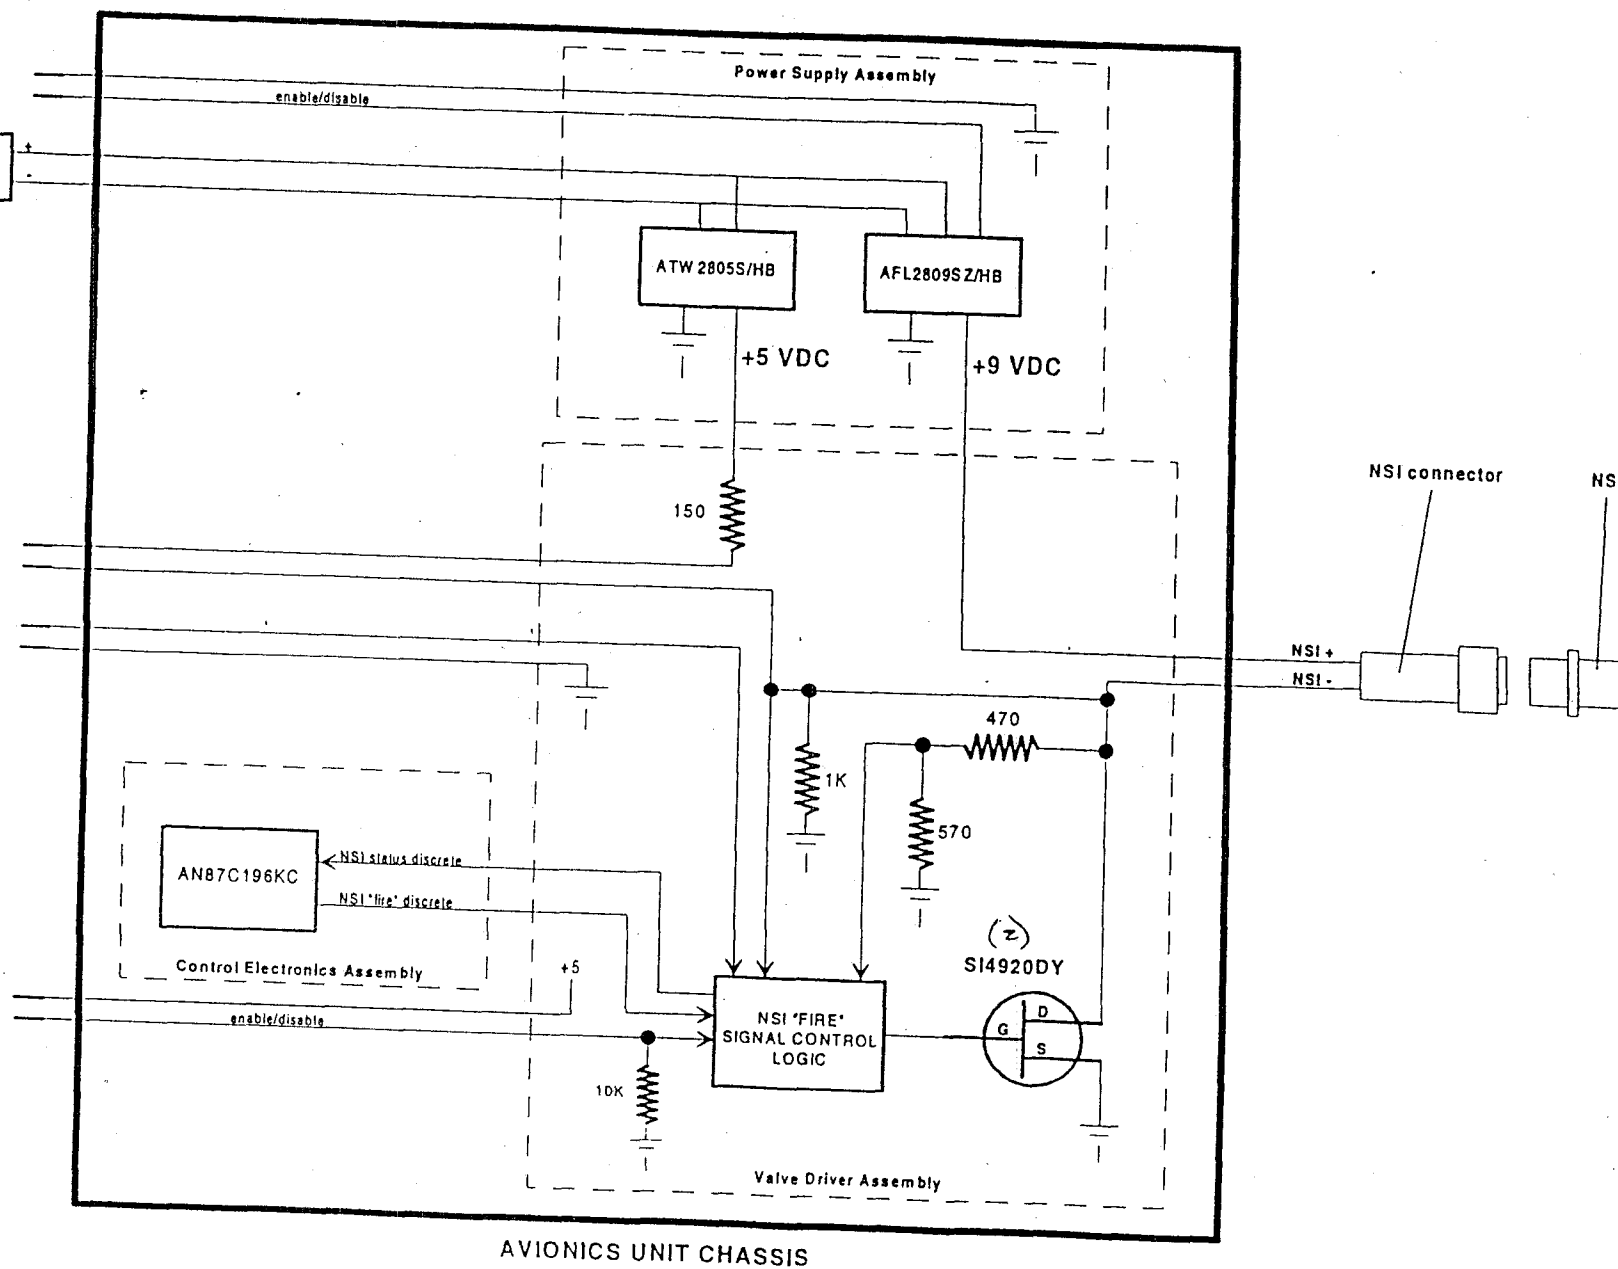
Figure 16: Circuit redesign - constant voltage (page 2 of 2)

PROPOSED SAFER NSI DRIVE CIRCUIT FLIGHT CONFIGURATION - OPTION #1

The peer review attendees felt that the FRB's troubleshooting efforts were acceptable and that the major and contributing factors were accurately identified. Two alternative design solution concepts were presented to the peer attendees: one option (Figure 16) uses the same basic STS-86 design concept but with voltage source (increased from 5 to 9 volts) and resistance modifications. The second option (Figure 17) involves a replacement of the current avionics approach with a "capacitive discharge" circuit similar to the design found on most other NSI systems. The peer group felt that both options were worth pursuing further and that the final candidate should be chosen, in general, based on which options provides the most margin (assuming there are no other major performance, cost, and/or schedule differences).
